EL CAPITAN STATE BEACH

GENERAL PLAN

July 1979

Santa Barbara/Ventura Coastali State Park System General Plan

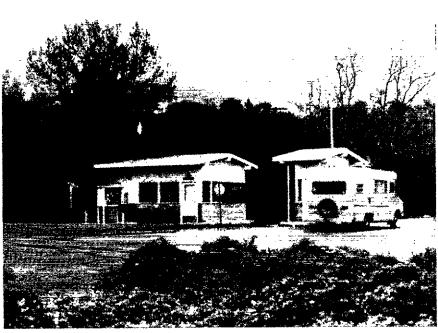
The visitor's center will be expanded to accommodate additional displays and programs.

- -- The existing visitor center is currently being partially used as an office for operations staff. Several interpretive panels are outside the visitor center. It is recommended that the visitor center be expanded to accommodate additional activities. Interpretive display panels discribing historic, archeological, or visual features will be located at various points in the unit (see General Plan Map).
